Materials Characterization of Irradiated Spectralon from the NIF Target Chamber

R. Chow, G. Frieders, W. Jensen, M. Pearson, P.
Datte

May 22, 2015

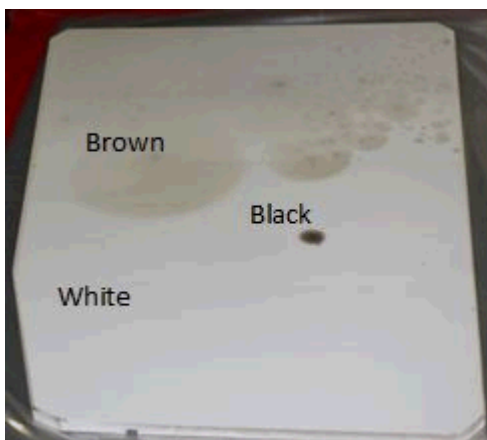
Spectralon plates extracted from the NIF target chamber in April of 2014 had been irradiated with a $\Sigma N_{\gamma} = 0.74$ Gy. The lower two Spectralon plates from NBI Q31 were selected for multiple materials analysis. The Spectralon plates were decontaminated by washing with hot water, wiped down with solvents, and allowed to decay until the radioactive levels were below that of levels found in the general public. These two plates were representative of the discoloration range observed in the other NBI Q31 plates, from a pristine white to brown to black, as represented in Figures 8. All non-white colorations were on the surface of the Spectralon facing target chamber center, whereas none of the discolorations extended to the backside of the Spectralon. One cm diameter core samples for chemical analysis and tensile samples for mechanical testing were machined, without lubrication, from these plates in areas that had a no visible discoloration, a brown color, a black color and from a Spectralon sample that was purchased in the same lot but never installed in target chamber. The sample designations are White-X, Brown-X, Black-X and Non-Irradiated, respectively, where X = 1 for samples machined from the left plate and X = 2 for samples machined from the right plate. The cover glass was broken during the target chamber extraction on the plate from the lower right assembly. The purpose of the red tape shown Figure 8b was to keep the glass in-place during the extraction procedure.

Figure 8a Spectralon samples (Label X = 1) were cored from the NBI Q31 sub-assembly, lower left plate, for RBS and XPS analysis.

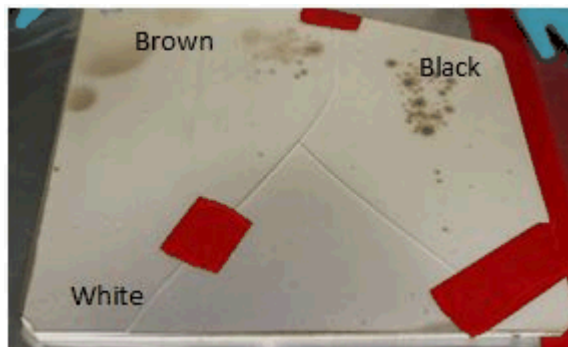
Figure 8b Spectralon samples (Label X = 2) were machined from the NBI Q31 sub-assembly, lower right plate for FTIR, SEM and mechanical characterization. Note the cover glass was broken during the target chamber extraction.

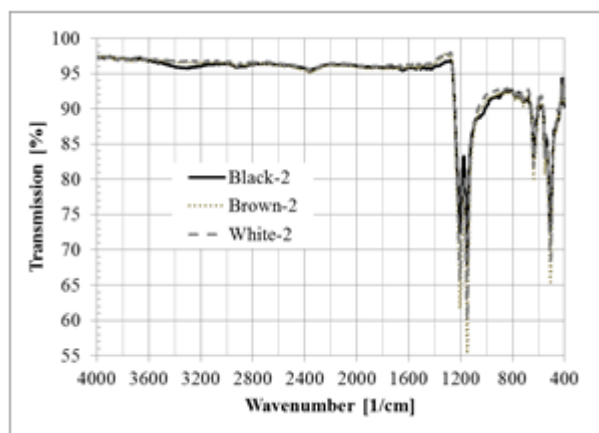
The Spectralon sample spectra were obtained using a Harrick Split Pea attenuated total reflectance (ATR) feature, equipped with a silicon crystal, mounted in a Perkin Elmer Spectrum GX FTIR spectrophotometer. The wavelength range scanned was 2.5 to $25 \mu\text{m}$ (4000 to 400cm^{-1} wavenumbers). The spectra from all the “-2” samples were essentially identical (Figures 9a). The slight transmission variations are possibly caused by the different surface roughness between the samples. The probe depth of the evanescent wave protrudes from the ATR crystal into the sample about 0.5 to $5 \mu\text{m}$. The FTIR library spectra routine identified each of the White-2, Brown-2 and Black-2 samples as PTFE (Figure 9b).

Figure 9a The samples are essentially identical per FTIR analysis.

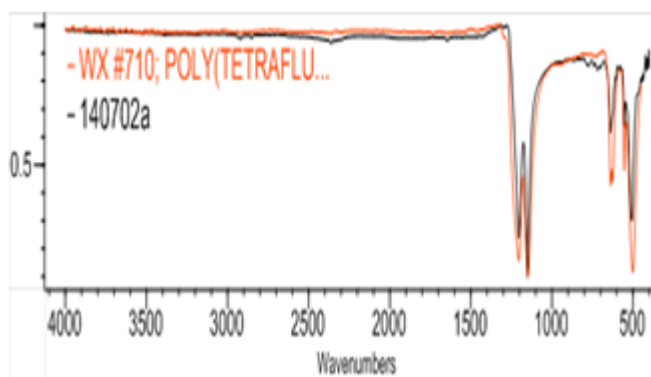
Figure 9b FTIR Spectra from the White-2 sample overlaid to that of PTFE from the FTIR spectra library.

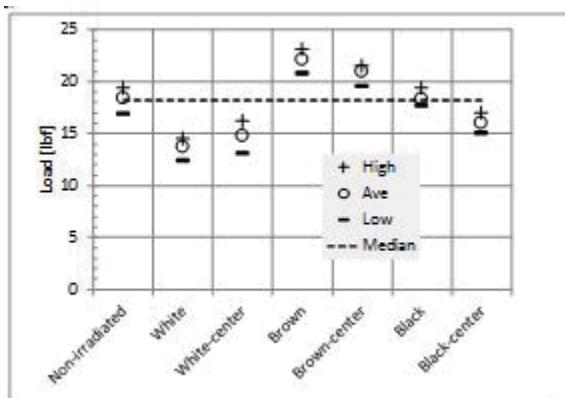
The mechanical data shows, in Figures 10a and b, that Brown-2 samples had the highest load and elongation values, followed by Black-2 samples, and lastly the White-2 samples. In this case, color change was not an indicator of any degradation in the mechanical properties. It is also believed that the variation in results from the various specimen groupings is most likely due to processing the material since the material is porous as can be seen in the SEM images. Small changes in cell structure can have large impacts on mechanical properties. This is further supported by the results

Figure 10a Tensile load averages

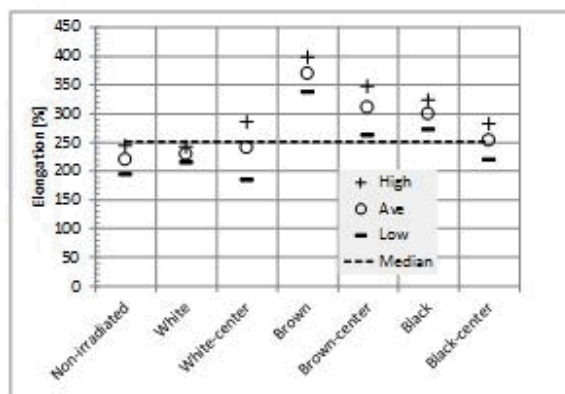
Figure 10b Elongation averages
